Hilton Hotel, Sydney

Case Study

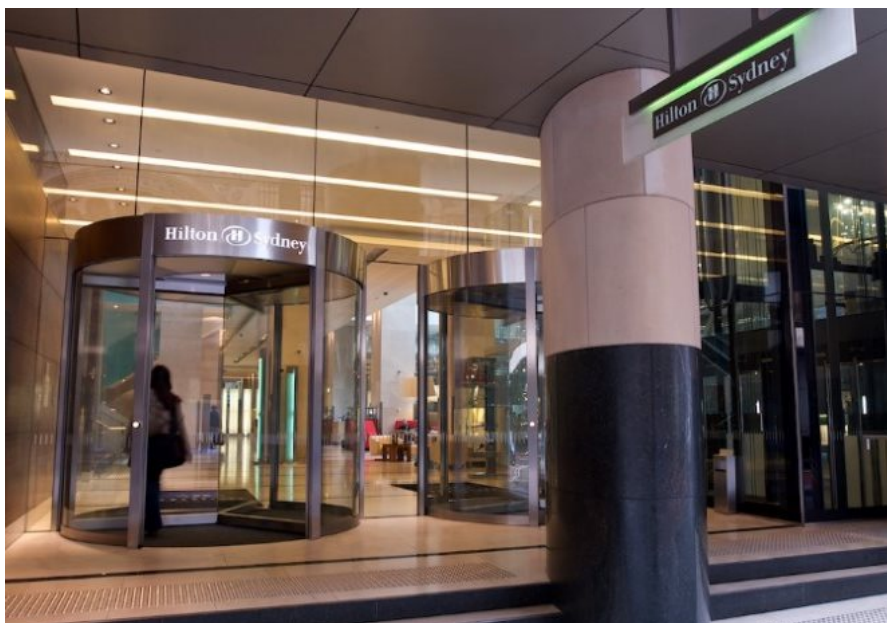
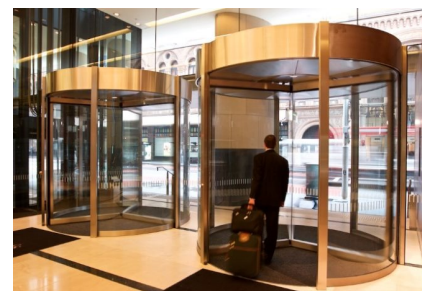
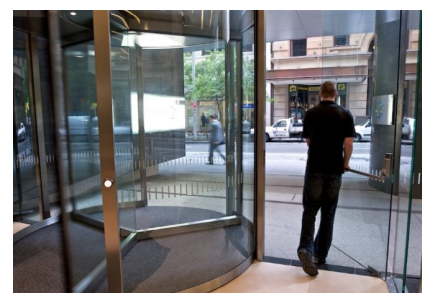
With the existing main entry sliding doors on Geogee Street, as well as the rear entry off Pitt Street, causing persistent wind problems for hotel staff and guests, the decision was made to replace these sliding doors with revolving doors to achieve airlocked entries to the hotel.

In an extensive site operation, the existing sliding doors were removed, along with the highlight glazing which was being supported off the steel transom.

Two Fullview revolving doors were then installed to the George Street entry, along with one Fullview door and motorised swing door to the Pitt Street entry. All doors were clad in lined stainless steel with custom illuminated canopy signage.

To maintain the existing requirement for smoke ventilation in an emergency, each revolving door was fitted with an automatic windback door wing to open on a re-trip signal.

For greater security after hours, the doors were fitted with motorised 'clamshell' night doors, which are in fact the sidewalls of the doors themselves automatically closing and electrically locking once the door, and associated lighting is turned off.
