Hilton Hotel, Sydney

Case Study

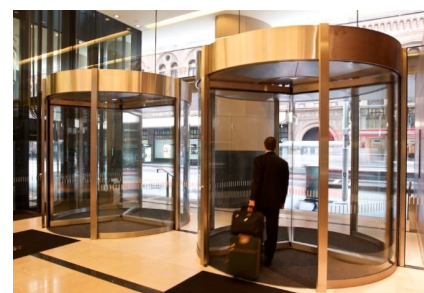
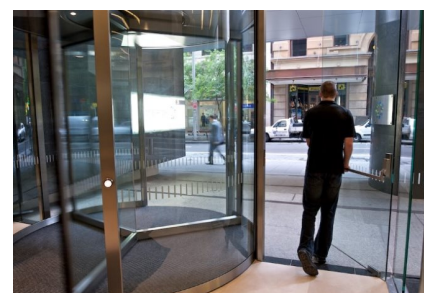
Two Fullview revolving doors were then installed to the George Street entry, along with one Fullview door and motorised swing door to the Pitt Street entry. All doors were clad in lined stainless steel with custom illuminated canopy signage.

To maintain the existing requirement for smoke ventilation in an emergency, each revolving door was fitted with an automatic windback door wing to open on a fire signal.

For greater security after hours, the doors were fitted with motorised 'clamshell' night doors, which are in fact the sidewalls of the doors themselves automatically closing and electrically locking once the door, and associated lighting is turned off.
